**UM-3724-98
1998 Dodge Durango**

**In-depth
Vehicle
Occupant
Report**

The University
of Michigan
Transportation
Research Institute

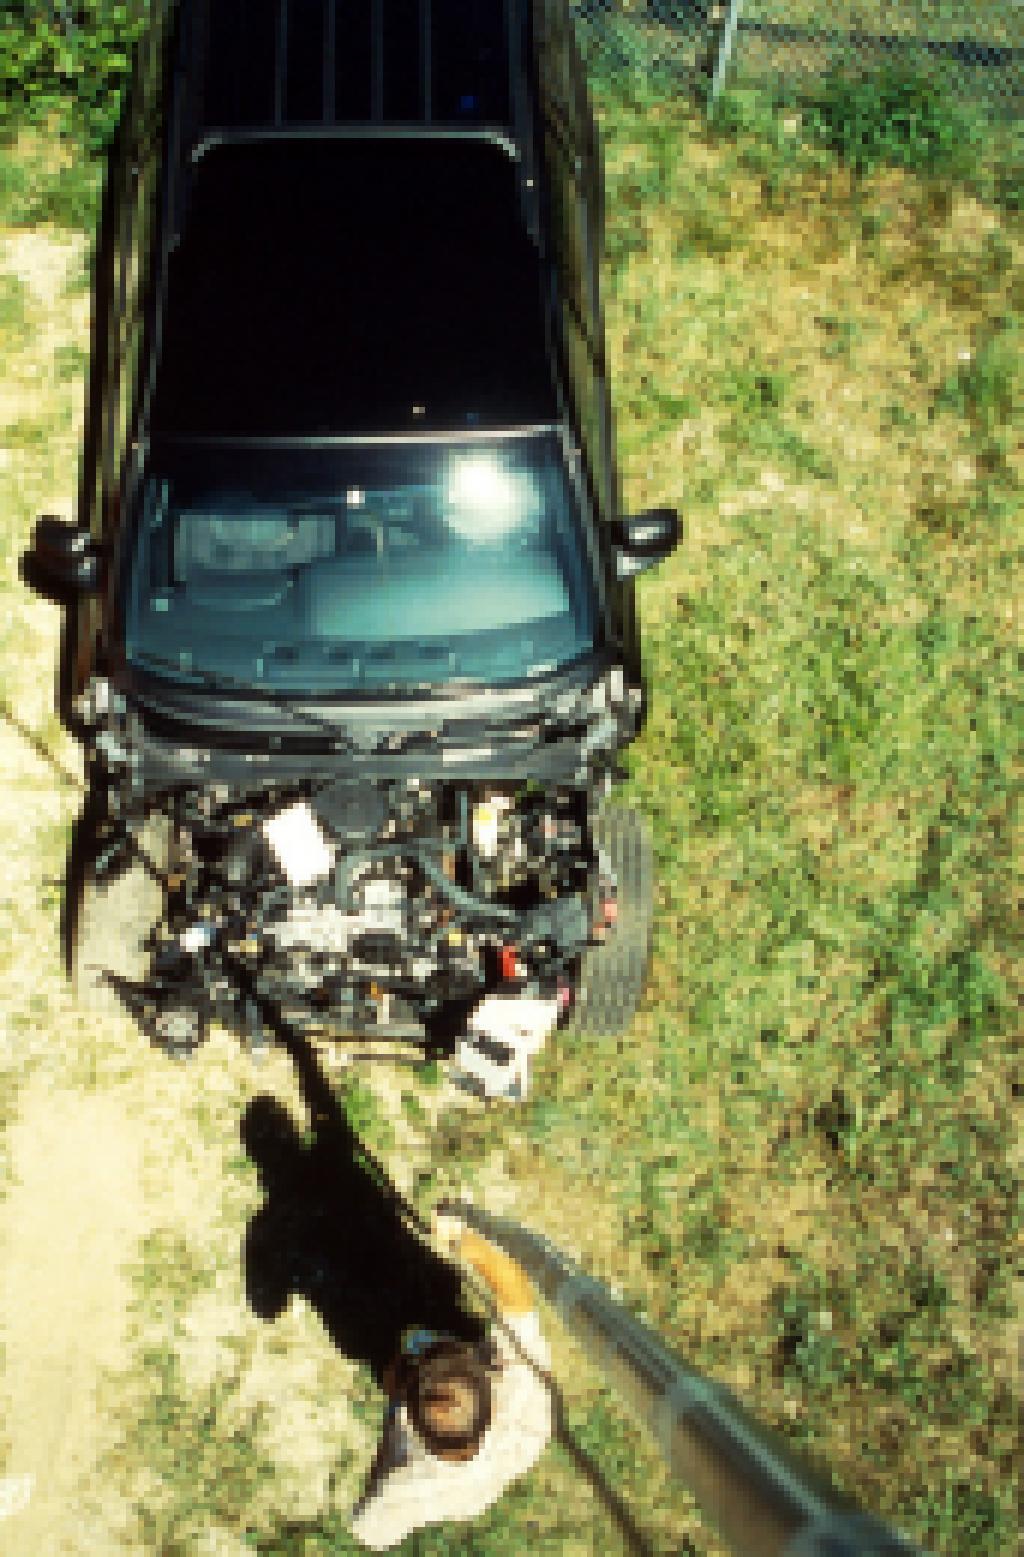
PN 3724-98 #3

(Slide 1) Case vehicle (A) was traveling north up a slope at a driver-estimated speed of 65 kph (40 mph) in the northbound through lane of a (slide 2) 3-lane asphalt road in a urban residential area. It was daylight, the sky was clear, and the road surface was dry and in good condition. Vehicle (B) was traveling south in the left-turn lane of the same road. Vehicle (B) made a left turn and went into the path of case vehicle (A). Case vehicle (A) was unable to stop in time and struck vehicle (B) in the left side with its front. Vehicle (B) was not available for inspection.

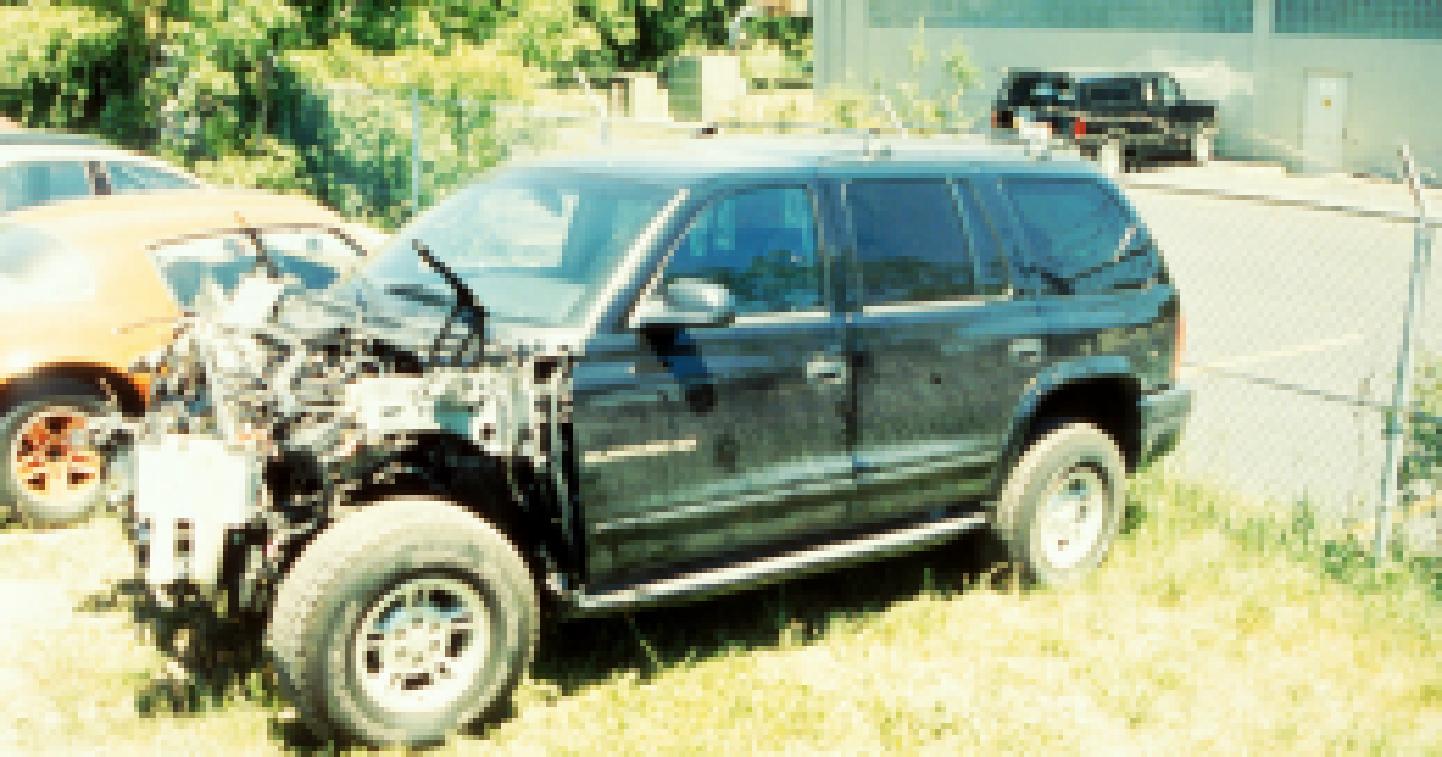
PN 3724-98 #4

(Slide 4) Damage to case vehicle (A) was moderate. (Slide 5) The force of the crash pushed the engine rearward, and the air cleaner/fuel injector was damaged due to contact with the firewall. (Slide 6) The radiator, upper radiator support, and (slide 7) engine compartment side rails were damaged and had been removed. (Slide 8) The hood was damaged. It is unknown if the rear edge of the hood was elevated, but it did not contact the undamaged windshield. (Slides 9 and 10) The front axle was damaged and the front wheels were out of alignment. (Slide 11) The left-front fender was damaged, but the wheelbase was increased 3 cm. (Slide 12) The right-front fender and right-front wheel were damaged, (slide 13) and the wheelbase was decreased 3 cm.

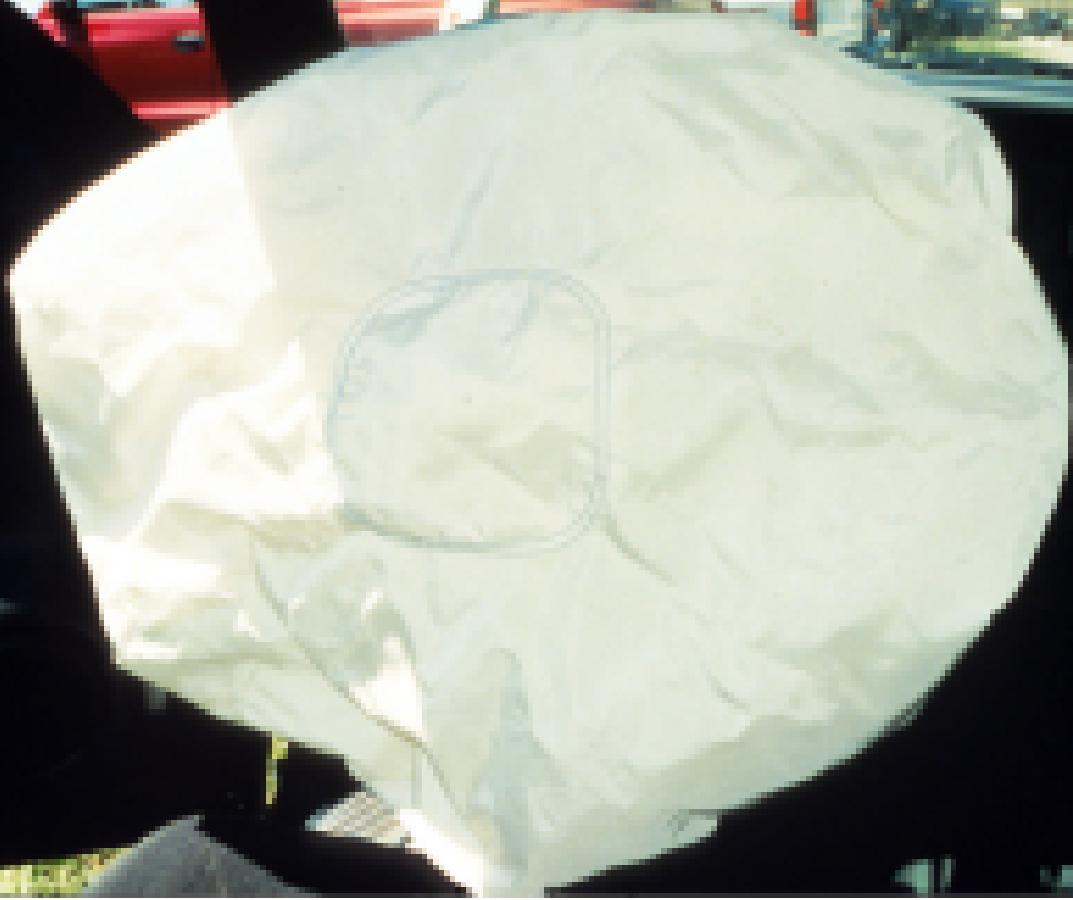
PN 3724-99 #14

(Slide 14) This vehicle was equipped with steering-wheel and (slide 15) passenger frontal-impact airbags, which deployed. (Slides 16 and 17) There was no damage to the steering-wheel rim or (slides 18 and 19) spokes. (Slide 20) The steering column appeared to be rotated upward and to the left. There were no intrusions. (Slide 21) The lower instrument panel (knee bolster)

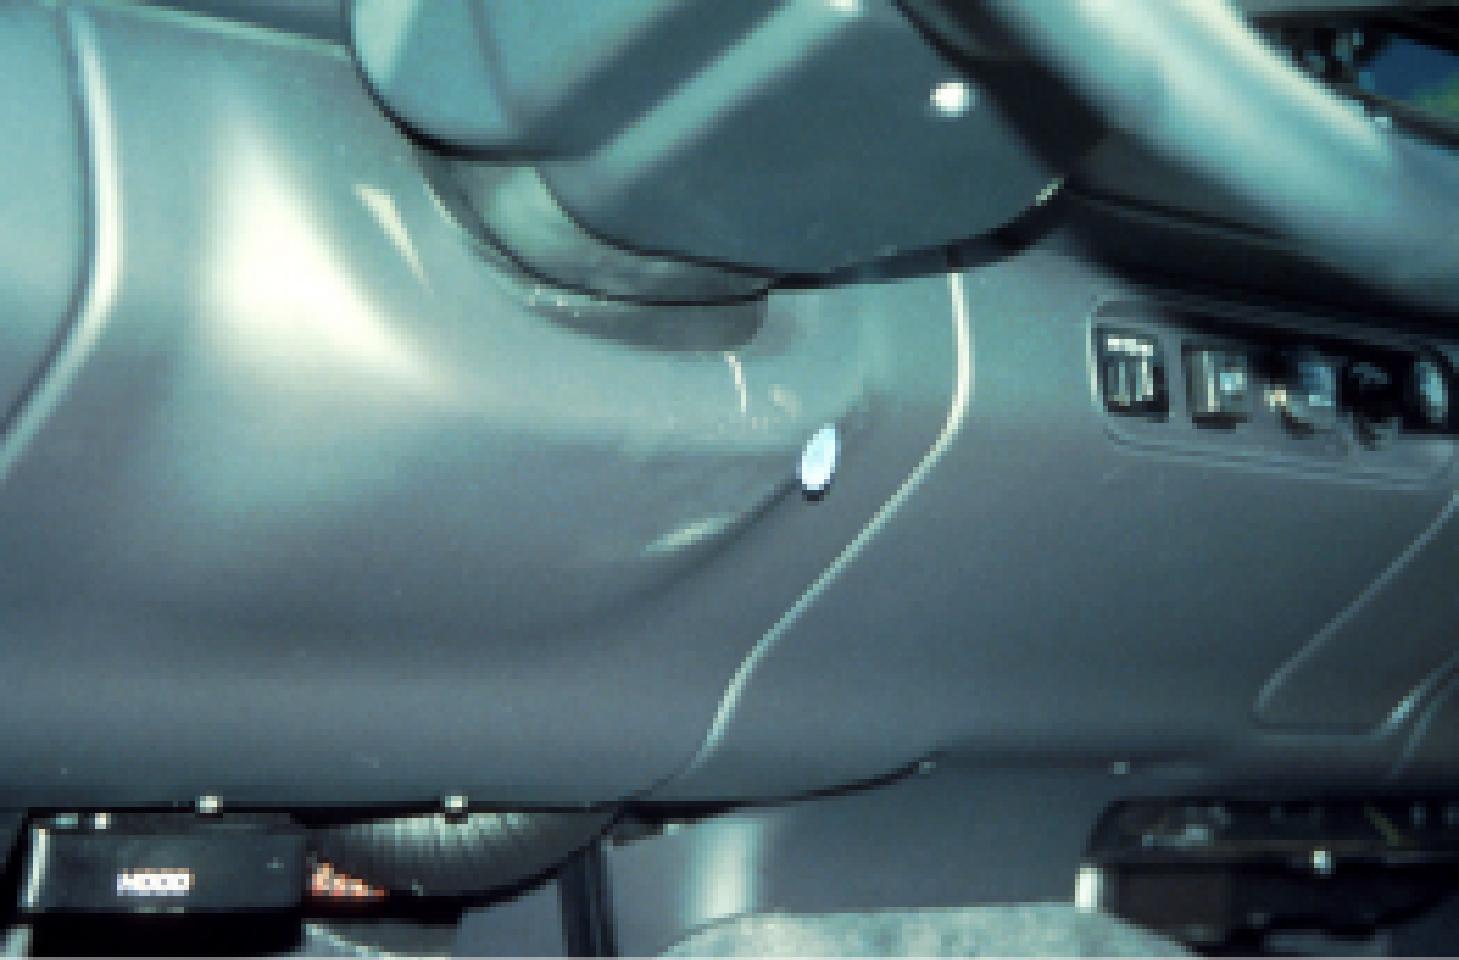
PN 3724-98 #20

was contacted and damaged by driver right leg contact. (Slide 22) The driver's plastic shoulder belt anchor cover was damaged. (Slide 23) The glove box area was not damaged. (Slide 24) The left-front door interior was not damaged. (Slides 25, 26, 27, 28, 29, 30, 31, 32, 33 and 34) There was no other observable interior damage.
